NATIONAL PROGRAM FOR INSPECTION OF NON-FEDERAL DAMS
NICHOLS POND DAM (VT.) (U) CORPS OF ENGINEERS WALTHAM MA
NEW ENGLAND DIV APR 80

Nichols Pond Dam VT00184

APR 1980

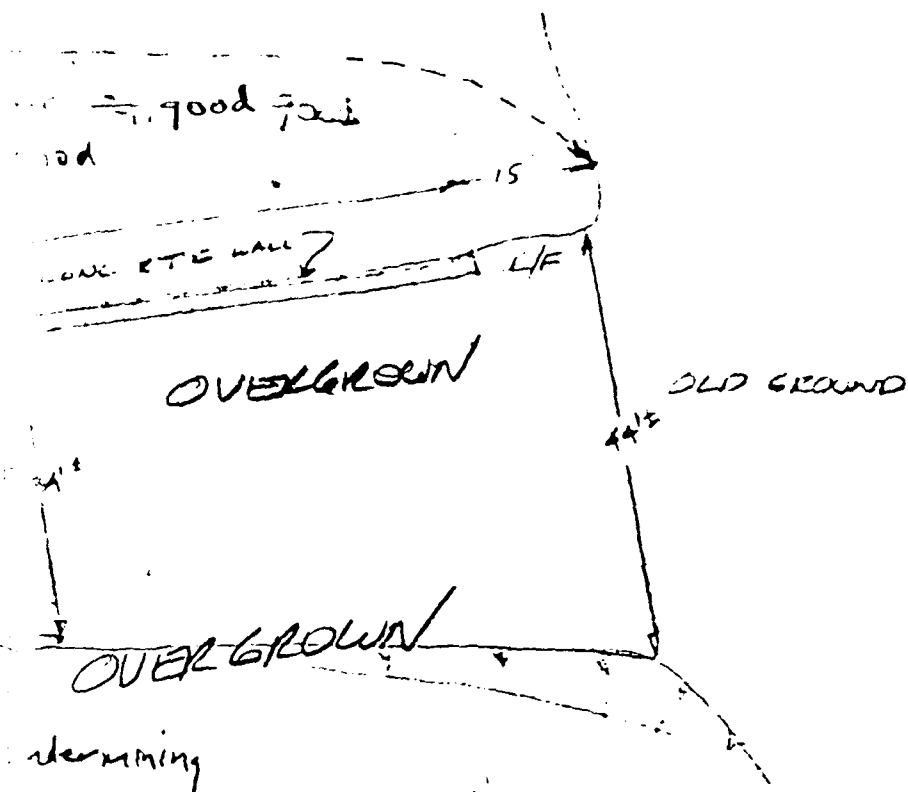
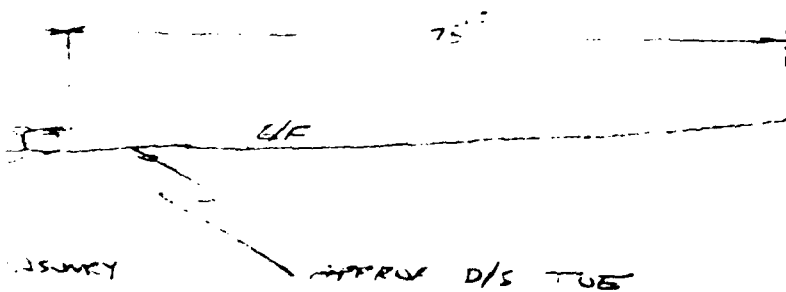
The concrete head wall making up the upstream face of the dam showed a battered effect due to wave and ice action. A bituminous material has been applied to the cracks to control

could not
see d/s face
11' below top of wall
